NASA/TP-2009-215791

Investigation of Helicopter Longeron Cracks

Abstract

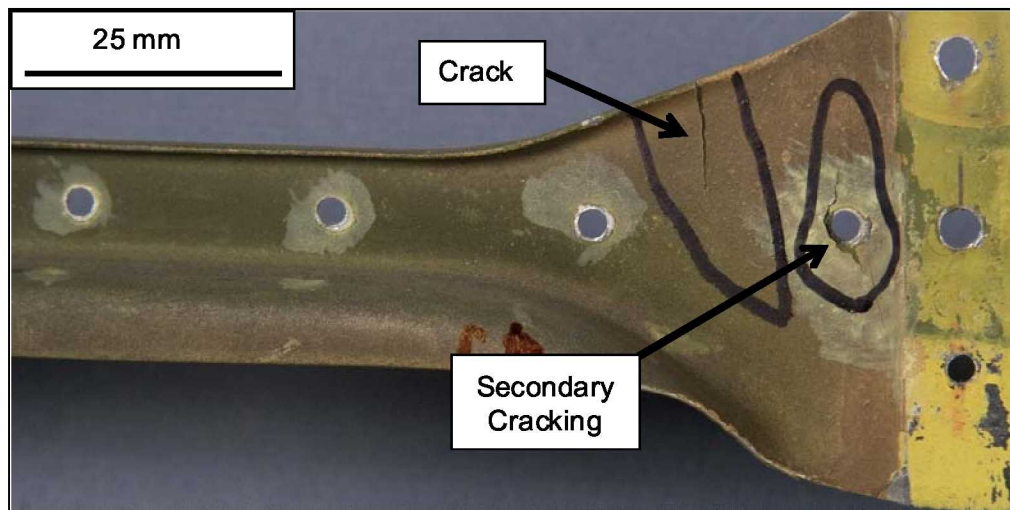
(a) Photograph of typical longeron crack with secondary cracking (Longeron #2, Crack #2).

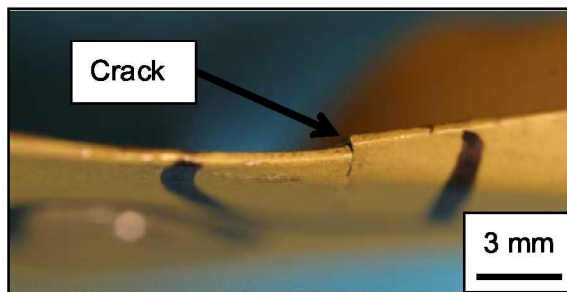
For these longerons, the orientations of Figures 1 and 2 are consistent in that the left direction in these figures corresponds to the forward direction on the vehicle. A total of eight (8) cracks were found in the four (4) longerons provided, as summarized in Table 1. All cracks were located in the low stiffness (flat) regions, in close proximity to the stiffened section. A typical crack is shown in Figure 3a. For this crack (Longeron #2, Crack #2), some secondary cracking was observed at a nearby fastener hole. With respect to the longeron orientation of Figure 2, every crack occurred on the left (forward) side of the bulkhead attachment station and appeared to initiate from the top edge region of the longeron. Some of the longeron cracks were observed to have some residual shear displacement such that the crack faces appeared as in Figure 3b, while other cracks did not exhibit this residual shear displacement and appeared similar to that shown in Figure 3c. The cracks with notable residual shear displacements (Longeron #1, Crack #1; Longeron #2, Crack #1; and Longeron #4, Crack #1) were the longest cracks examined

(b) Photograph of crack with residual shear displacement (Longeron #4, Crack #1).

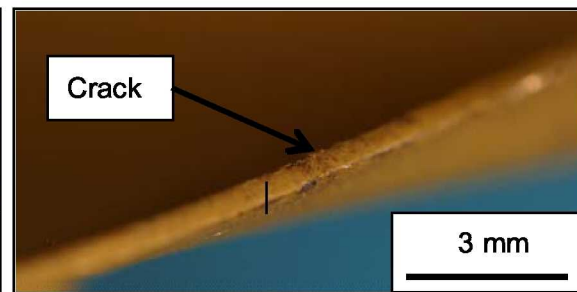
(c) Photograph of crack without residual shear displacement (Longeron #4, Crack #2).

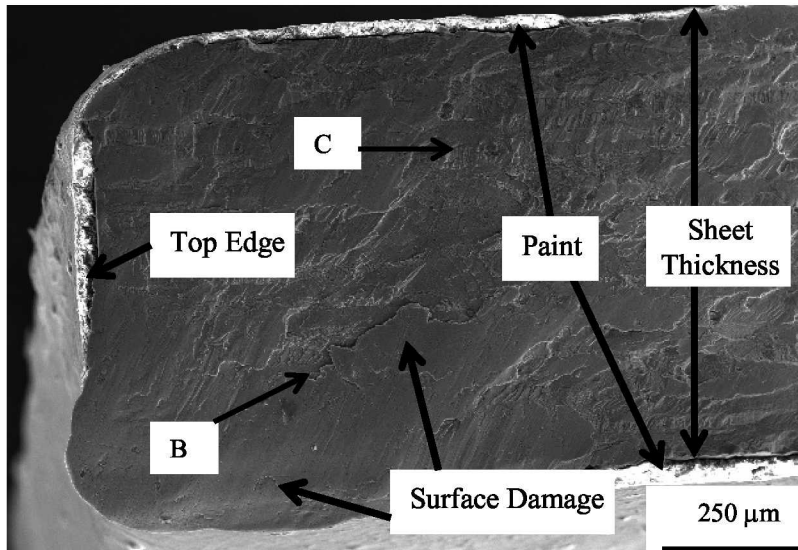
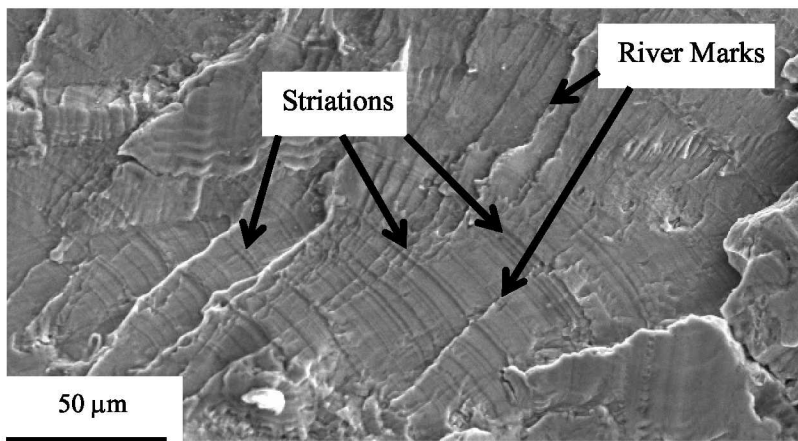
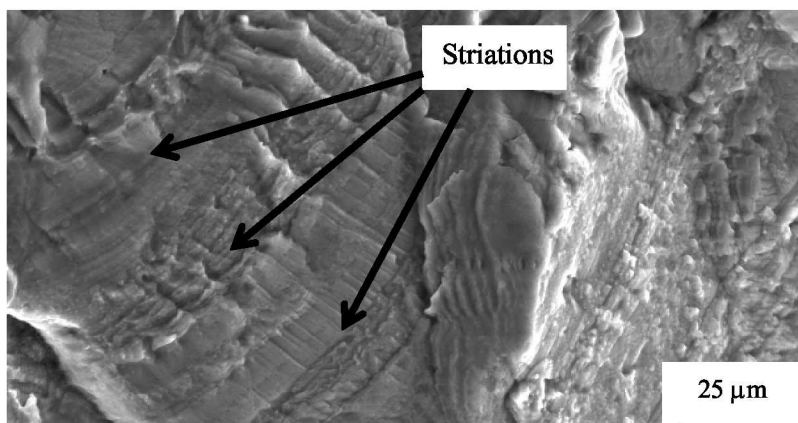
Figure 4. SEM crack-surface micrographs for Longeron #1, Crack #1.

SEM crack-surface micrographs for Longeron #1, Crack #1 (a crack approximately 0.85 inches long (21.59 mm) that initiated at Station 164.87) are shown in Figure 4. In Figure 4a, the sheet thickness direction is oriented vertically with the top edge of the longeron on the left side of the figure. Bright white regions seen on the outer surfaces of the sheet are paint. Large portions of the crack surface appear to be damaged or smeared, likely a result of the crack surfaces coming into contact with each other. Crack-surface features that may have been in these damaged regions have been destroyed; however, there are undamaged regions of the crack surface where striations have been found, and are shown at higher magnification in Figures 4b and 4c. These striations are compelling evidence that crack growth was driven by fatigue loading (ref. 1). Additionally, river marks (fatigue crack surface features that are typically perpendicular to striations, oriented parallel to the direction of crack growth) are labeled in Figure 4b.

(a) Lower-magnification image showing the entire sheet thickness.

(b) Higher-magnification image of fatigue striations, region B.

(c) Higher-magnification image of fatigue striations, region C.

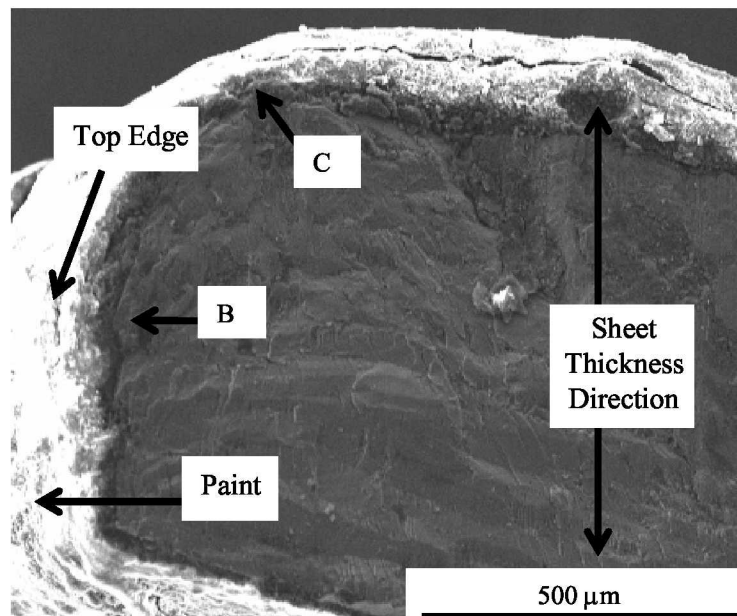
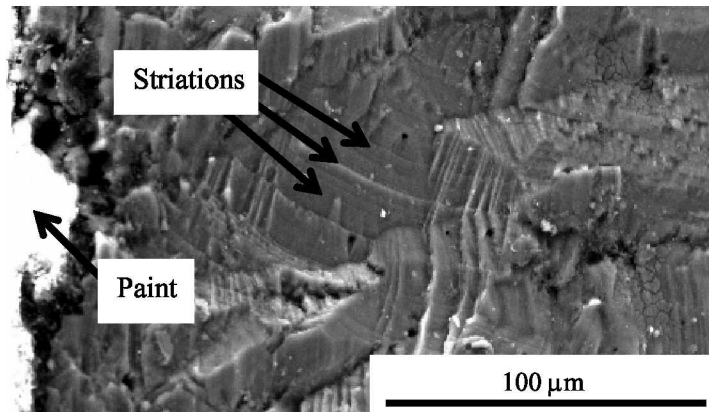
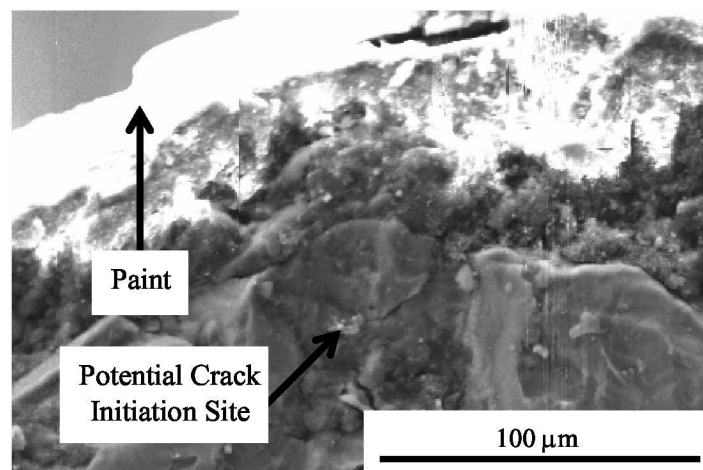
Figure 5. SEM crack-surface micrographs for Longeron #1, Crack #2.

Crack-surface examinations of Longeron #1, Crack #2 (a crack approximately 0.38 inches long (9.65 mm) occurring at Station 155.75), reveals the presence of fatigue striations, microscopic features consistent with fatigue crack growth (see Figure 5). A lower-magnification image of the crack surface is shown in Figure 5a corresponding to the top side of the longeron in the region where crack initiation appears to occur. The sheet thickness (0.025-inch-thick) direction is oriented vertically in this image. Two regions of interest are denoted, which are shown at higher-magnification in Figures 5b and 5c. Fatigue striations are easily identified in Figure 5b and at multiple other locations on the crack surface (ref. 1). The slight curvature of these striations (indications of the crack front at some previous point in time) can be traced back to determine the crack initiation site, which is shown at higher-magnification in Figure 5c. Crack-surface features suggest that the location of crack initiation was near the surface of the sheet material. No obvious defect in the region of crack initiation was noted (e.g., corrosion pit, scratch, tool mark, etc.). The bright region near the outer surface of the sheet (extreme right side of Figure 5c) is a result of the paint covering the longeron.

(b) Higher-magnification image of fatigue striations, region B.

(c) Higher-magnification image of apparent crack initiation site, region C.

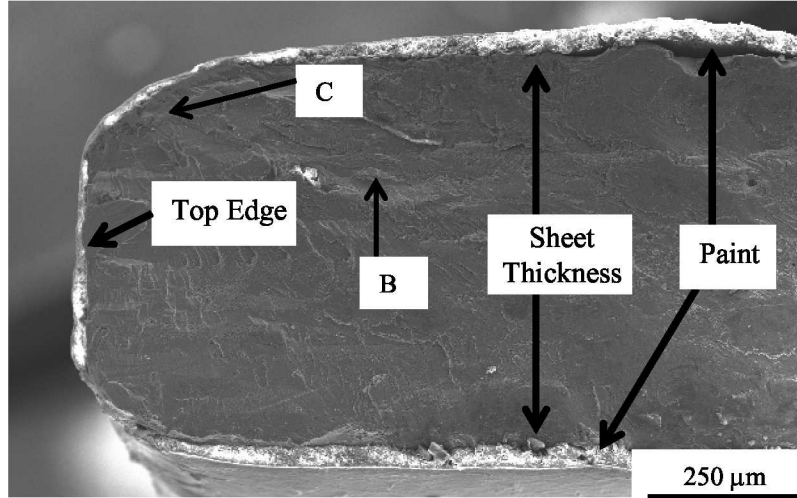
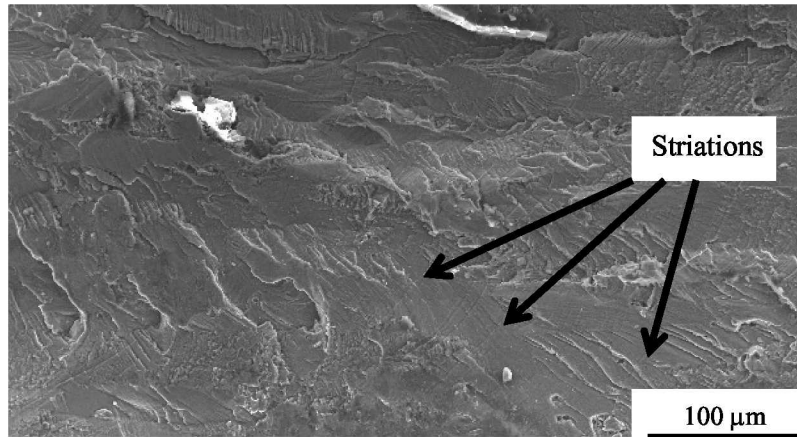
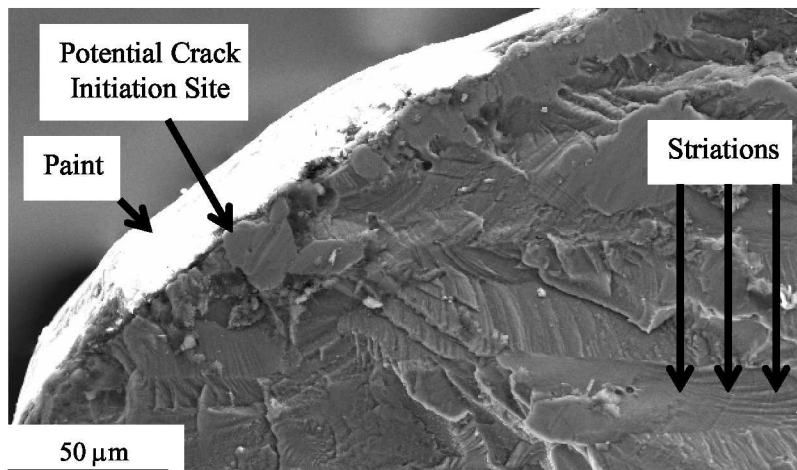
Figure 6. SEM crack-surface micrographs for Longeron #1, Crack #3.

SEM crack-surface micrographs for Longeron #1, Crack #3 (a crack approximately 0.15 inches long (3.81 mm) that initiated at Station 185.89) are shown in Figure 6. The crack surface corresponding to the top edge of the longeron is shown in Figure 6a, where the top edge of the longeron is on the left side of the figure and the sheet thickness direction is vertical. Paint on the surface of the longeron is seen as the bright white regions near the top and bottom of the figure. The crack surface is nearly free of mechanical contact damage and striations can be readily observed over nearly the entire surface (ref. 1). A typical striated region is shown in Figure 6b. Striations can be traced back to an apparent origin, which is located near the top left corner of the sheet, with respect to the orientation presented in Figure 6a, and is shown at higher magnification in Figure 6c.

(b) Higher-magnification image of fatigue striations, region B.

(c) Higher-magnification image of apparent crack initiation site, region C.

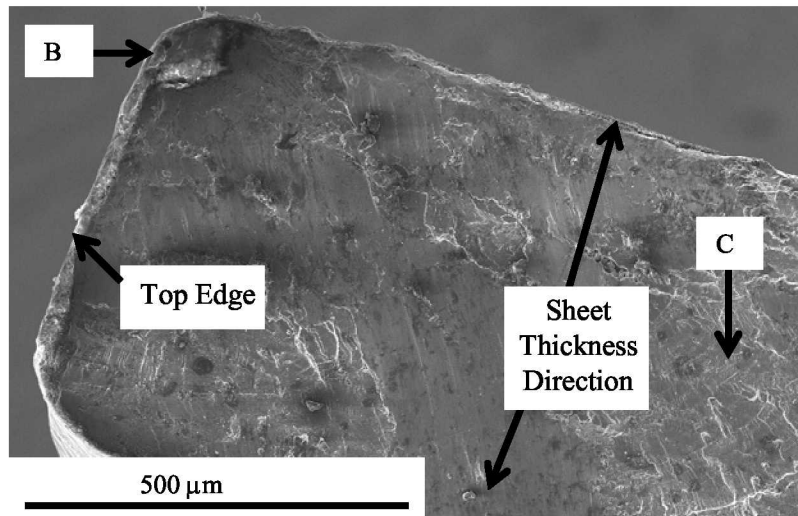
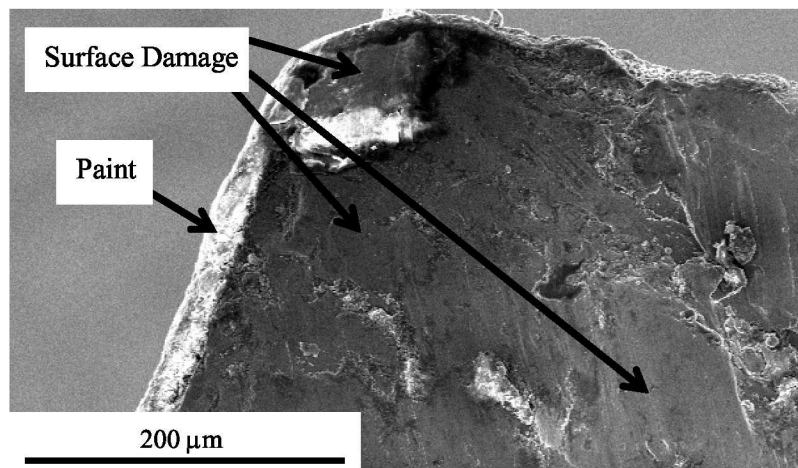
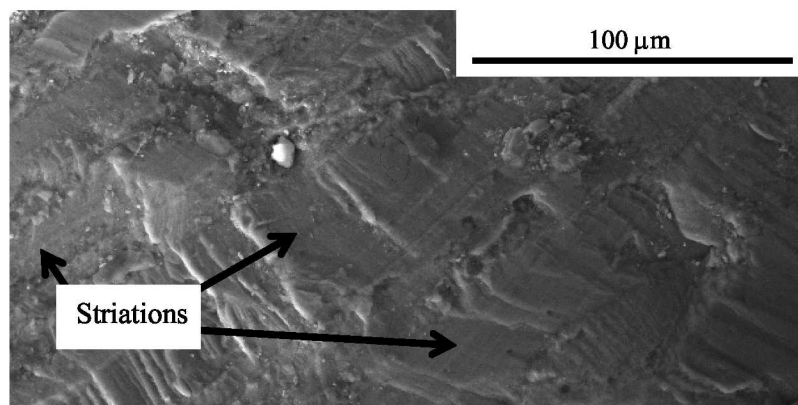
Figure 7. SEM crack-surface micrographs for Longeron #2, Crack #1.

SEM crack-surface micrographs for Longeron #2, Crack #1 (a crack approximately 0.62 inches long (15.75 mm) that initiated at Station 146.62) are shown in Figure 7. A lower-magnification image of the crack surface corresponding to the top edge of the longeron (apparent crack initiation region) is shown in Figure 7a. A higher-magnification image of the crack surface, corresponding to the upper left corner of Figure 7a, is shown in Figure 7b. Here, the crack surface appears to be smeared (contact damage) such that most of the crack-surface features (e.g., fatigue striations) have been destroyed. However, further from the top edge of the longeron (crack surface regions corresponding to the left side of Figure 7a), fatigue striations are observed (ref. 1). A typical region of fatigue striations is shown at high magnification in Figure 7c.

(b) Higher-magnification image of crack-surface damage, region B.

(c) Higher-magnification image of fatigue striations, region C.

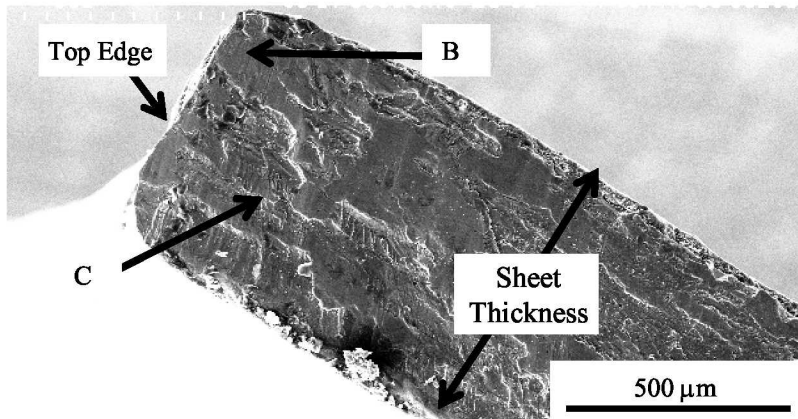
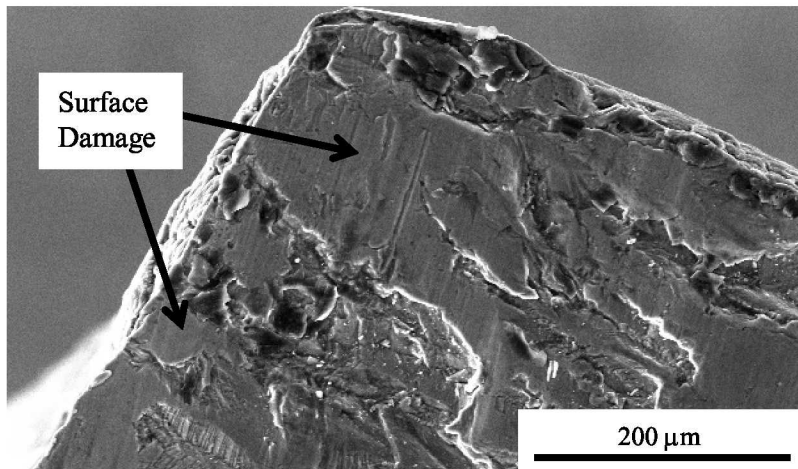
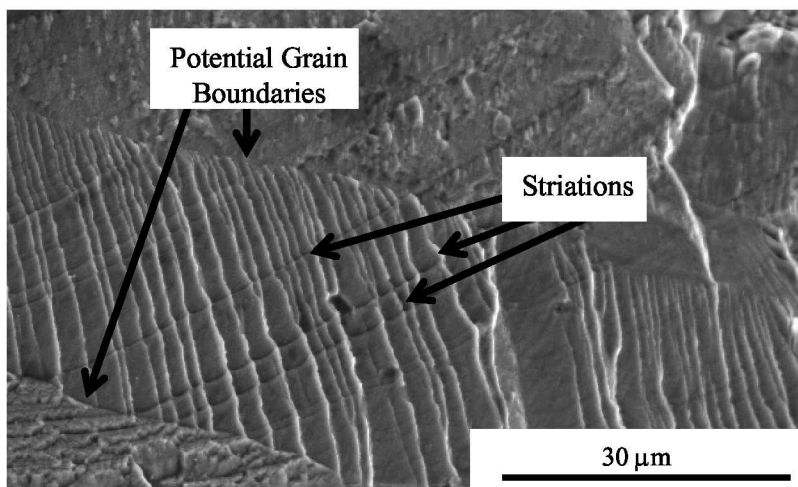
Figure 8. SEM crack-surface micrographs for Longeron #2, Crack #2.

SEM crack-surface micrographs for Longeron #2, Crack #2 (a crack approximately 0.44 inches long (11.18 mm) that initiated at Station 164.87) are shown in Figure 8. The crack surface near the top edge of the longeron is shown at lower-magnification in Figure 8a. A higher-magnification image of the crack surface, corresponding to the upper left corner of Figure 8a, is shown as Figure 8b. Similar to the results previously shown in Figure 7 (Longeron #2, Crack #1), the crack surface appears to be smeared (contact damage) such that most of the crack-surface features, like fatigue striations (if they did exist), have been destroyed. However, there are a few islands of undamaged crack surface that contain striations (ref. 1). An example of these striations is shown in Figure 8c. Here, “river marks” (fatigue crack surface features that are typically perpendicular to striations, oriented parallel to the direction of crack growth) can be seen oriented vertically and striations are seen arcing across the image, as the crack appeared to grow from the upper left corner of the figure to the lower right. In this image, a third set of interesting linear features can be seen that are believed to be grain boundaries (ref. 1). Here, it is believed that the region containing the clear striations is within a grain oriented in a manner to promote striations while the regions above and below are grains having different orientations such that striations are less pronounced. If these features are indeed grain boundaries, the grains in this sheet product are elongated in the sheet directions and thin in the direction of the sheet thickness. Further work is needed to characterize the microstructure of this sheet product.

(b) Higher-magnification image surface damage, region B.

(c) Higher-magnification of fatigue crack striations, region C.

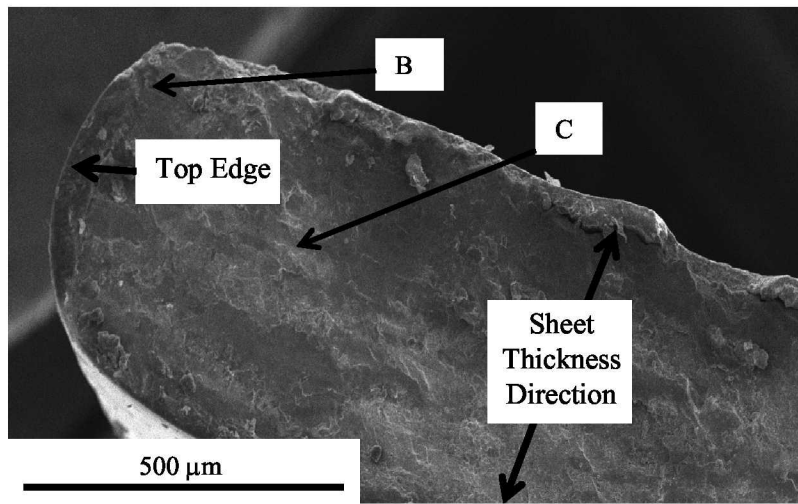
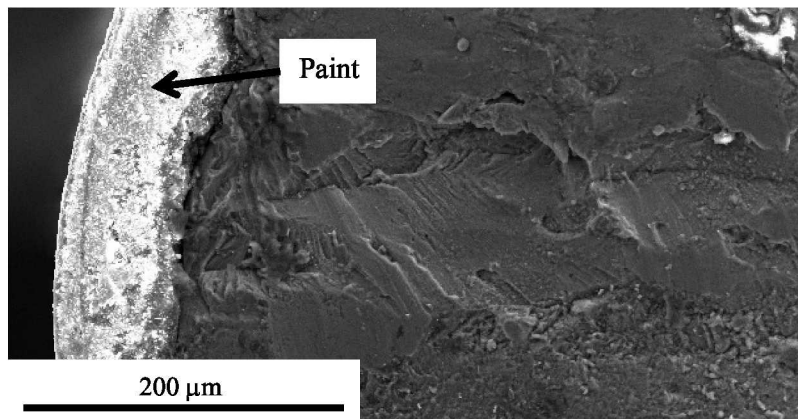
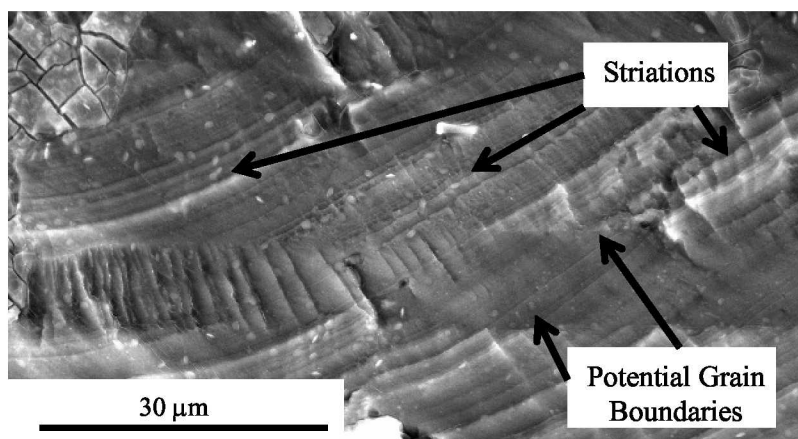
Figure 9. SEM crack-surface micrographs for Longeron #3, Crack #1.

SEM crack-surface micrographs for Longeron #3, Crack #1 (a crack approximately 0.31 inches long (7.87 mm) that initiated at Station 164.87) are shown in Figure 9. The crack surface region near the top edge of the longeron is shown at lower-magnification in Figure 9a. A higher-magnification image of the surface near the edge is shown in Figure 9b. Here, the top edge of the longeron sheet is on the left side of Figure 9b; the bright area corresponds to the paint on the outer surface. Similar to the results for the cracks found in Longeron #2, portions of the crack surface appear to be smeared or damaged. However, islands of undamaged surface can be seen near the center of Figure 9b. Some of these undamaged regions are striated, as shown in Figure 9c, indicating that the crack propagation was driven by cyclic loading (ref. 1).

(b) Higher-magnification image of surface damage, region B.

(c) Higher-magnification image of fatigue striations, region C.

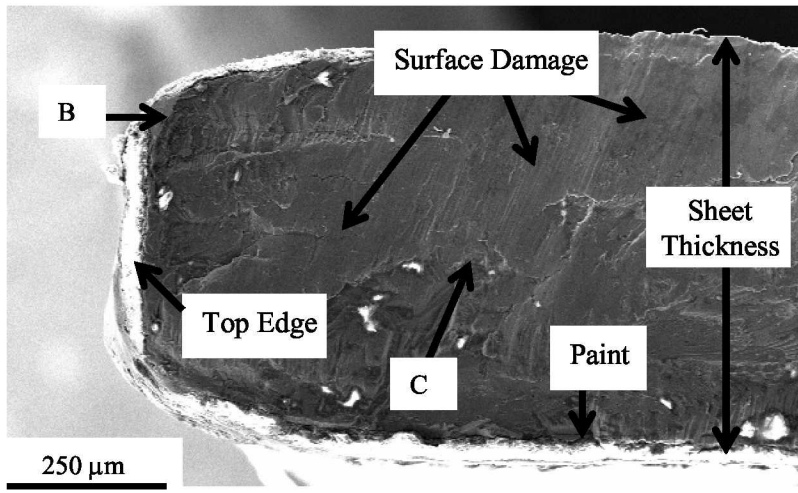
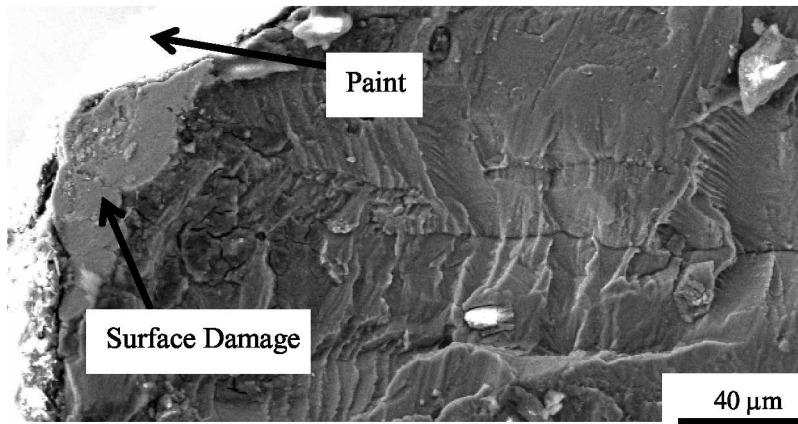
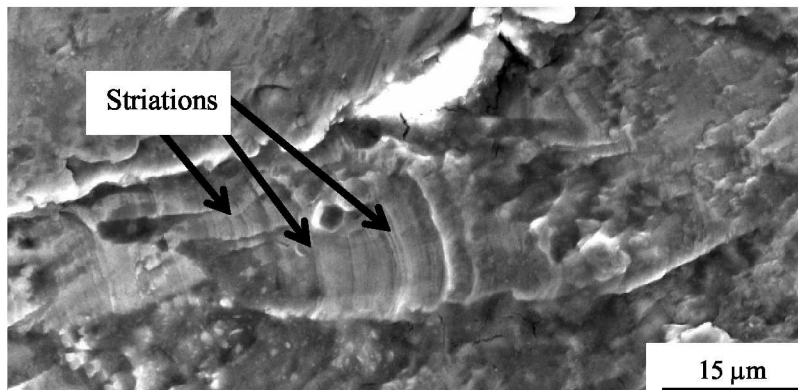
Figure 10. SEM crack-surface micrographs for Longeron #4, Crack #1.

SEM crack-surface micrographs for Longeron #4, Crack #1 (a crack approximately 0.49 inches long (12.45 mm) that initiated at Station 155.75) are shown in Figure 10. A relatively low-magnification image of the entire sheet thickness is shown as Figure 10a; here, the top edge of the longeron corresponds to the left side of the figure. Large portions of the crack surface appear to be damaged, presumably smeared as crack faces came into sliding contact, as observed in Figure 3b. In these damaged regions, crack-surface features of interest have been destroyed. A higher-magnification image of the damaged corner region is shown as Figure 10b. However, there are crack-surface regions that escaped mechanical damage and in these regions fatigue striations were observed (ref. 1). A typical example of striations in these undamaged regions is shown as Figure 10c.

(b) Higher-magnification image of surface damage, region B.

(c) Higher-magnification image of fatigue striations, region C.

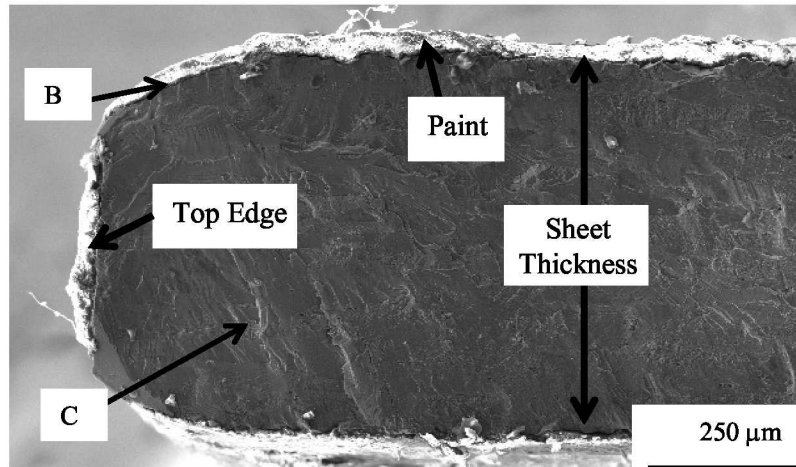
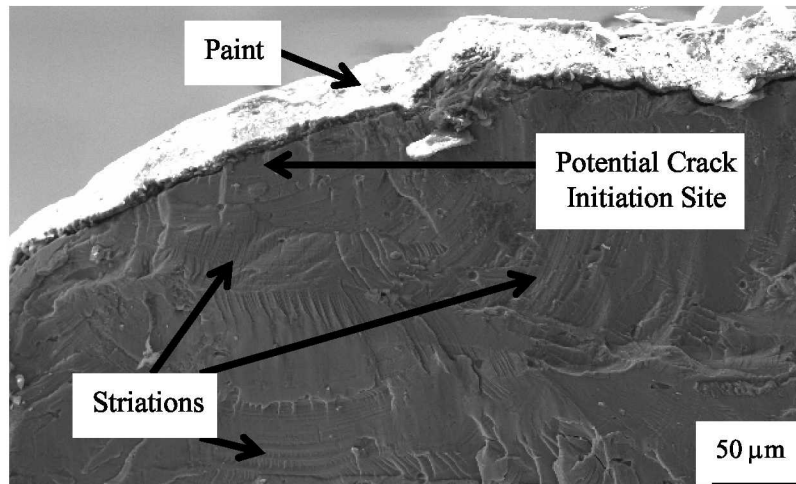
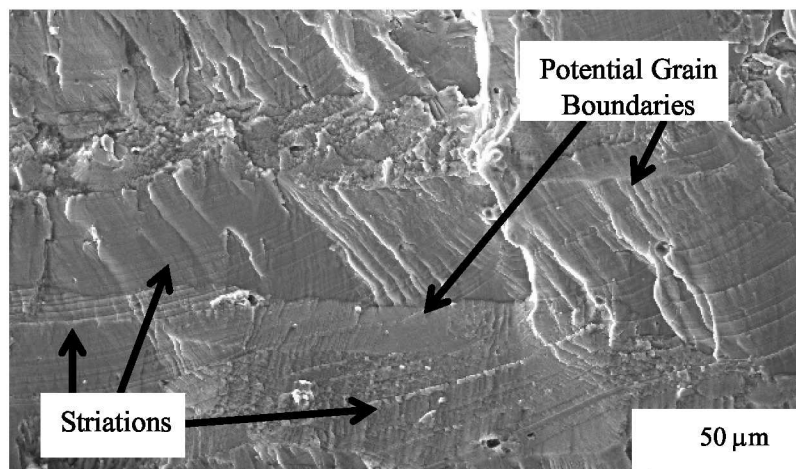
Figure 11. SEM crack-surface micrographs for Longeron #4, Crack #2.

SEM crack-surface micrographs for Longeron #4, Crack #2 (a crack approximately 0.18 inches long (4.57 mm) that initiated at Station 164.87) are shown in Figure 11. A relatively low-magnification image of the entire sheet thickness is shown as Figure 11a; here, the top edge of the longeron corresponds to the right side of the figure. Recall from Figure 3b that this relatively short crack exhibited no residual shear displacement. It is likely not coincidental that these crack surfaces are nearly free of contact or smearing damage. Nearly the entire crack surface contains fatigue striations (ref. 1). These fatigue striations can be traced back to an apparent crack initiation site, which is shown at higher magnification as Figure 11b. No obvious crack initiation feature (e.g., scratch, pit, or other defect) was observed near the crack initiation site, which suggests that surface defects were not a contributing factor in crack initiation. Fatigue striations are shown at high magnification in Figure 11c. In this image, the crack surface appears similar to that of Longeron #2, Crack #2 (Figure 8c) and Longeron #3, Crack #1 (Figure 9c), where features that are believed to be grain boundaries can be identified in the image.

(b) Higher-magnification image of apparent crack initiation site, region B.

(c) Higher-magnification image of fatigue striations, region C.

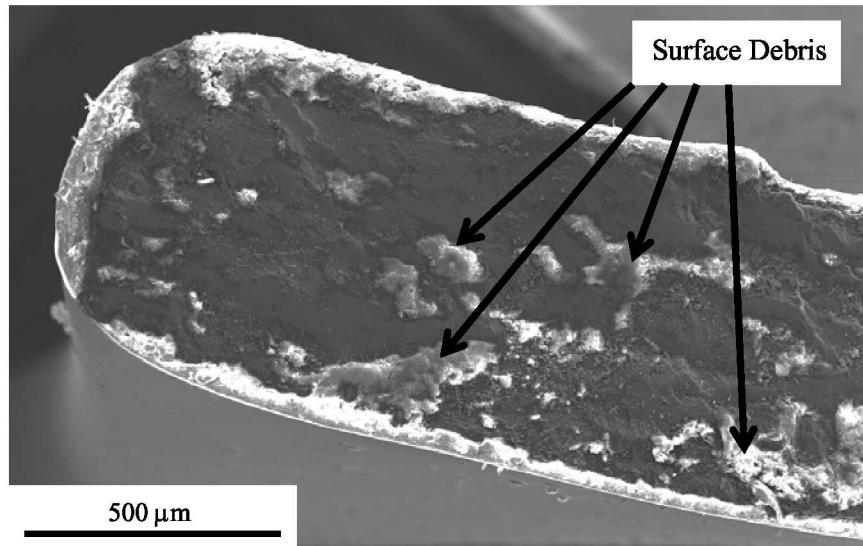
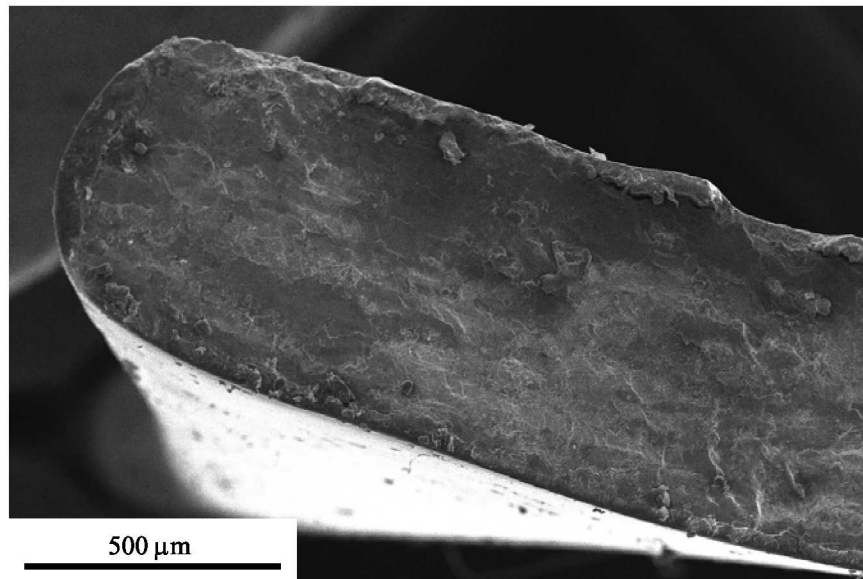
Figure 12. Images of typical crack surface (Longeron #3, Crack #1).

Typically, the crack surfaces were covered with debris that obscured the microscopic features of interest. To examine these features, the crack surfaces were ultrasonically cleaned in acetone, which successfully removed most of the debris without damaging the crack surfaces or the paint on the external surfaces of the longerons. The SEM images shown in Figures 4-11 were taken from clean surfaces. However, before cleaning, the dirty surfaces were examined in the SEM and chemically analyzed using Energy Dispersive X-ray (EDX) Spectroscopy (ref. 2). Crack surfaces of Longeron #3, Crack #1 are shown in Figure 12 both before cleaning the crack surfaces (Figure 12a) and after cleaning (Figure 12b). The crack surface debris is readily seen as the bright white regions in Figure 12a (absent in Figure 12b), a result of surface charging in the electron beam of the SEM. An EDX analysis taken of the debris (white regions in Figure 12a) indicates the presence of chlorine (25.3% weight), oxygen (16.6%), silicon (15.7%), sulfur (11.3%), sodium (9.0%), potassium (7.4%), phosphorus (6.0%), calcium (5.4%), and aluminum (3.3%). Similar chemical signatures have been obtained from other crack surfaces.

(a) Crack surface with debris before cleaning.

(b) Crack surface after cleaning.

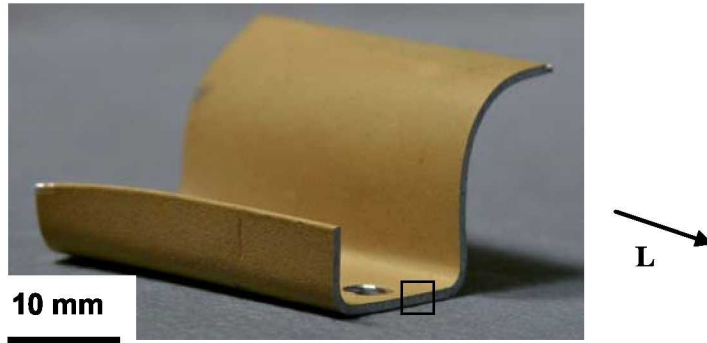
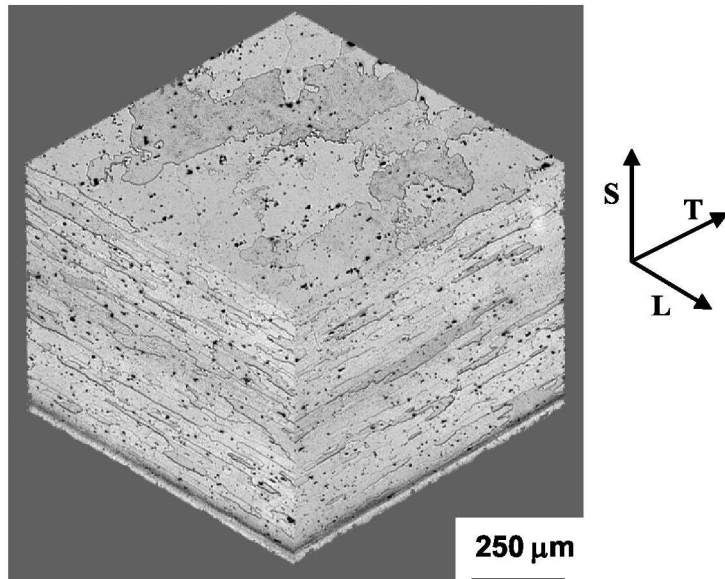
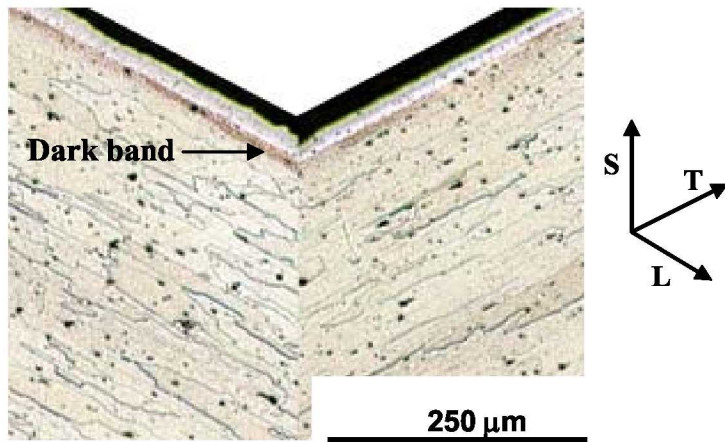
Figure 13. Results of metallurgical analysis of aluminum alloy 7075 longeron sheet material.

The microstructure of the aluminum alloy 7075 sheet is shown in Figure 13. For this microstructural analysis, a sample of material was cut from Longeron #1, immediately aft of Station 155.75. As indicated by the boxed region in Figure 13a, the material analyzed corresponded to the portion of the longeron that was fastened to the tail-boom fairing skin. Surfaces normal to the sheet directions were cut, mounted, etched² and polished for metallurgical analysis, and the corresponding images were arranged to appear as a three-dimensional cube of the material, herein termed “orthogonal metallurgical cube.” See Figure 13b for an orthogonal metallurgical cube of the longeron sheet material; here, the bottom edge of Figure 13b corresponds to the outer edge of the longeron sheet. The orthogonal surfaces used were termed “L”

(perpendicular to the length of the longeron), “T” (perpendicular to the vertical longeron direction as described in Figure 1), and “S” (perpendicular to the 0.025-inch sheet thickness direction). Examination of the dark lines in Figure 13b (presumably grain boundaries) indicates large grain areas on the S-surface with long and flat grain areas along both the L-surfaces and T-surfaces. These observations are typical of aluminum sheet material and a flattened pancake-shape grain structure. A portion of Figure 13b is shown at higher magnification in Figure 13c to better show microstructural boundaries. Here, the typical spacing between linear indications on both the L-surfaces and T-surfaces is nearly 20 μm , consistent with the hypothesis that the features observed in Figures 8c and 9c are grain boundaries.

Examination of the orthogonal metallurgical cube of Figure 13b reveals the presence of what appears to be a dark band near the outer surface of the sheet material (see bottom of Figure 13b). This discoloration occurred in the same near-surface region where small grain sizes were observed (recall Figure 14). A chemical analysis (EDX) was performed on near-surface and interior regions of the polished surfaces. SEM images of regions examined are shown in Figure 15. In these images, the sheet material is seen at the bottom with the paint layer near the top. The near surface region selected for analysis is shown with a box in Figure 15a and the interior region (approximately 60 μm from the surface) is indicated by a box in Figure 15b. The chemical analysis results, which are summarized in Table 2, indicate that the near surface region contains less alloying elements (zinc, copper, and magnesium) than the interior region, which has a composition typical of aluminum alloy 7075 (ref. 4). This depletion of alloying elements at the surface may result in a degradation of mechanical properties, such as poor resistance to crack initiation. In all cases where crack surface observations permitted (recall Figures 5, 6, and 11), crack initiation sites were always located on the corner of the longeron cross-section near the intersection of sheet surface (where a depletion of alloying elements was observed) and the top edge of the longeron where bending stresses are likely greatest. Further study is needed to determine if the chemical depletion contributed to the cracking.

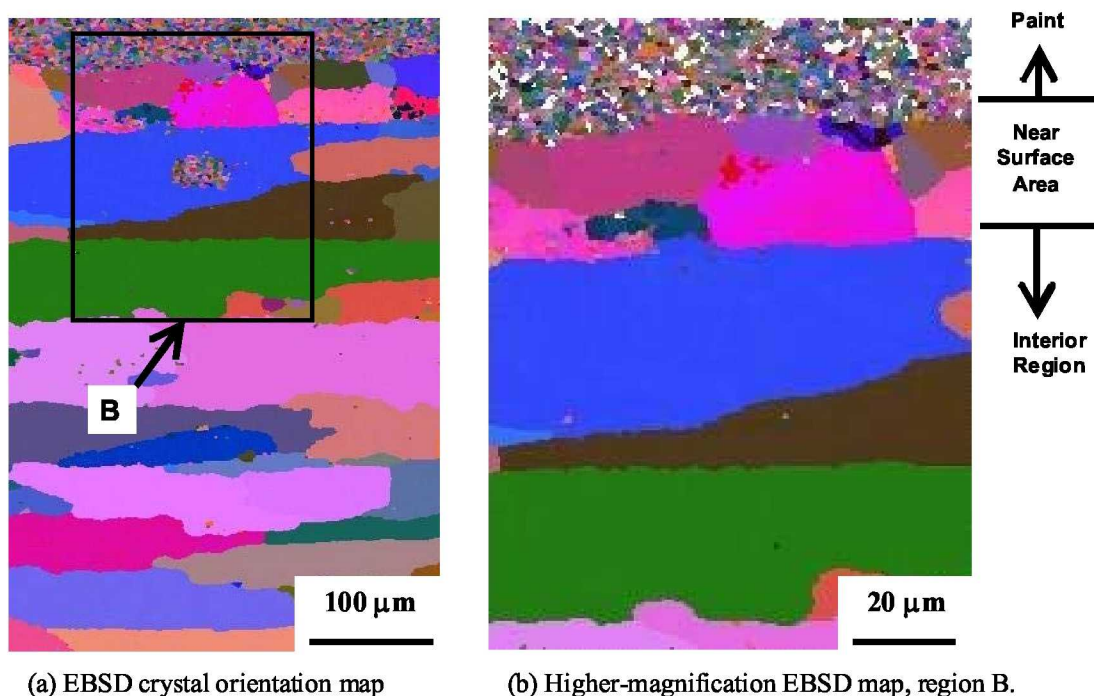
Figure 14. Near-surface crystal orientation maps generated by EBSD.

To confirm that the linear indications observed in Figure 13 are indeed grain boundaries, the physical metallurgy of the sheet material was analyzed using an SEM equipped with Electron Back-Scatter Diffraction (EBSD) to generate crystal orientation maps (ref. 2). A section of the longeron material (cut from Longeron #1, immediately aft of Station 155.75) was mounted and prepared for EBSD analysis, exposing a surface normal to the L-direction as defined in Figure 13, and having the same nominal orientation as the crack faces. The sample was mounted in an epoxy material to preserve the integrity of the edges (prevent rounding during polishing) and polishing was performed with care to eliminate surface residual stresses. EBSD data were collected across the sample, and then analyzed to produce crystal orientation maps of the near-sheet-surface material, which are presented in Figure 14. Figure 14b is a higher-magnification crystal orientation map of region B, which is indicated in Figure 14a. The paint, near surface area, and interior regions are indicated in Figure 14b. The crystal orientation map consists of thousands of points, each assigned a color based on its crystal orientation. In this image, grains appear as continuous regions having the same color. The grains seen in the interior region appear to be elongated and approximately 25 μm thick (in the sheet thickness direction, seen in Figure 14 as the vertical direction), which is consistent with the grain size estimates obtained from SEM observations of Figures 8c, 9c, and 11c. The grains within 25 μm of the sheet surface have a significantly smaller grain size compared with the interior region.

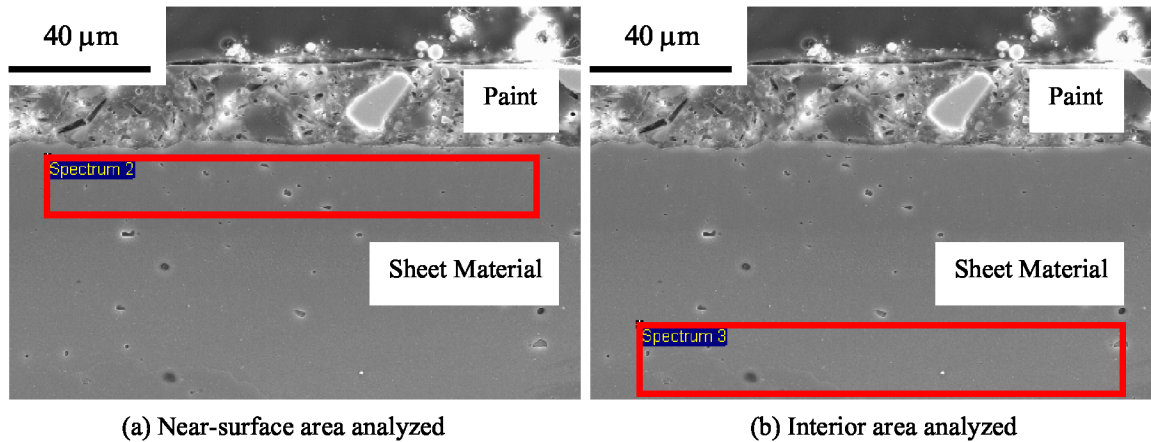
Figure 15. Near-surface and interior regions used for chemical analysis.

During metallurgical analysis of the longeron sheet material, an unusual feature was observed on polished surfaces of near-surface samples. (Recall, this layer appeared as a dark band near the bottom of Figure 13b.) Chemical analysis of near-surface region (Figure 14a) revealed that, in comparison to both the interior chemistry and typical aluminum alloy 7075 chemistry (ref. 4), it was relatively poor in the alloying elements copper, zinc, and magnesium, and appeared to contain traces of iron. This alloying element depletion may result in a local degradation in mechanical performance, including resistance to cracking. In the examples where crack-surface features were used to determine an apparent crack initiation site (Longeron #1, Crack #2; Longeron #1, Crack #3), these crack initiation sites occurred near the longeron sheet surface (where alloying element depletion was observed). EBSD results (Figure 15) revealed that the typical grain sizes within this near-surface alloying-element-depletion region were significantly finer than those within the longeron sheet interior. Additionally, the absence of corrosion
